The Upshot of the 2012 Flooding on Structural Components and Fabrics of Buildings at Ogbaru, Anambra State Nigeria

Abstract The study examined the effect of the 2012 flooding on structural components and fabrics of buildings at Ogbaru Local Government Area of Anambra State. It also examined the heights of the ground floors and foundations of the buildings respectively in relation to the height of the flood. Questionnaire survey on the selected households and physical examination on the building structures were carried out. The study revealed that most buildings in the area were either fully or partially submerged during the flood incidence. It further revealed that there were no very severe damages on the structural components of the buildings, despite that most of the buildings have low ground floor levels (74%) and shallow foundations (68%) below 300mm. However, building fabrics and elements such as finishes and electrical fittings were severely damaged when the flood height rose 1 metre above the ground floor level. More so, the study revealed that the flood severely damaged both the structural components and fabrics of very old, weak and mud buildings. Based on this, the study

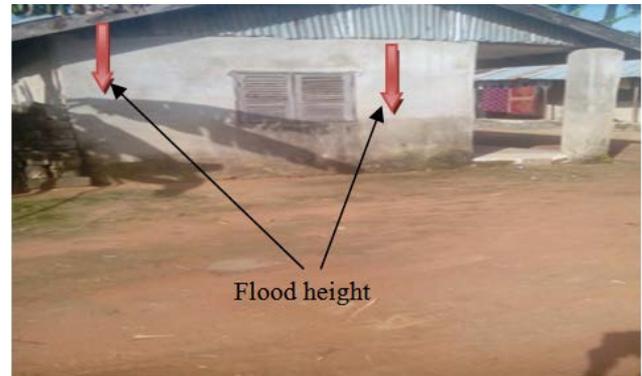
From Figure 3, about 68% of the buildings have foundations depths of 300mm or less (see also plate 1). Likewise, more than 74% of the buildings have ground floor level height of 300mm or less. Figure 1 also showed that during the 2012 flooding, about 56 % of the buildings showed flood depth mark of between 300-600mm, 28% showed flood depth mark of more 600mm. It further revealed that this depth increased significantly during the flooding and got to a depth of more than 1m. With the water rising above the floor level and coming into contact with internal finishes, it left most of the fittings and fabrics damaged.

From the physical observations of the buildings under study, it was observed that most buildings had columns and beams but were lying on a very shallow foundation, with low ground floor level. No building was built with plinth (see plates 1 - 3).

Plate 1. Building on low ground floor level and shallow foundation with arrows showing the depth of 2012 flooding

To this end and based on the outcome of this study, professional, residents and prospective house owners who wish to erect new buildings should raise the ground floor level of the buildings to at least above 1 metre, the foundation depths of the buildings in the area should also be made at least 1 metre or the buildings should be suspended on plinths to allow the easy flow of flood water as the case may be.

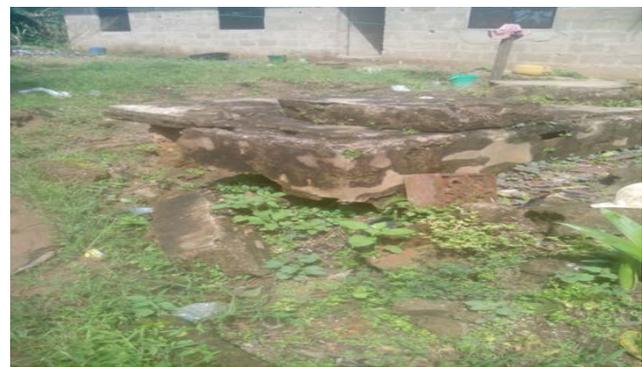
Consequently, greater percentages of the buildings with very heavy structural damages were building that were not properly reinforced (buildings lacking columns and beams), buildings with very shallow foundation, low ground floor level, mud houses, old and weak buildings and buildings under construction.

Plate 2. Building without columns and beam

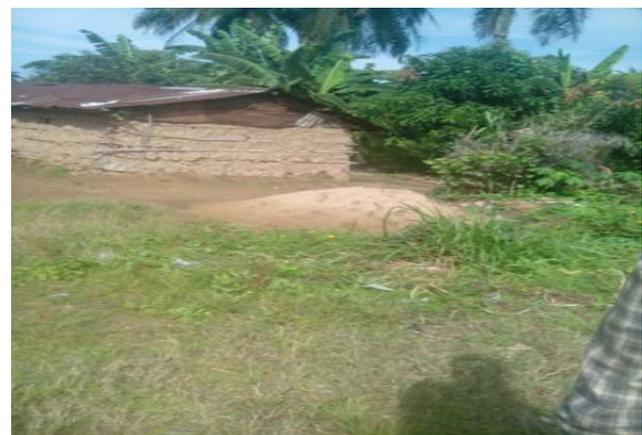
Plate 3. Mud house

It was also revealed that majority of the buildings which suffered structural damages were very old and weak buildings, mud houses, buildings with shallow foundations and buildings under construction. Though it was confirmed that the study area is flood prone which usually occur on yearly basis, most building in the area were with low ground floor level and none were constructed with plinth which may have aided in elevating the buildings above the perennial flood level.
