Analysis of Failures of Leaf Springs on the Continuous Casting Machines

Abstract At the first look very simple and for several hundred years used elastic element can be critical part in complex equipment where its failure invokes extraordinary high losses. In the paper is given a treatment for the solution of spring failure problem by experimental methods of stress analysis and resulting proposals for its final solution.

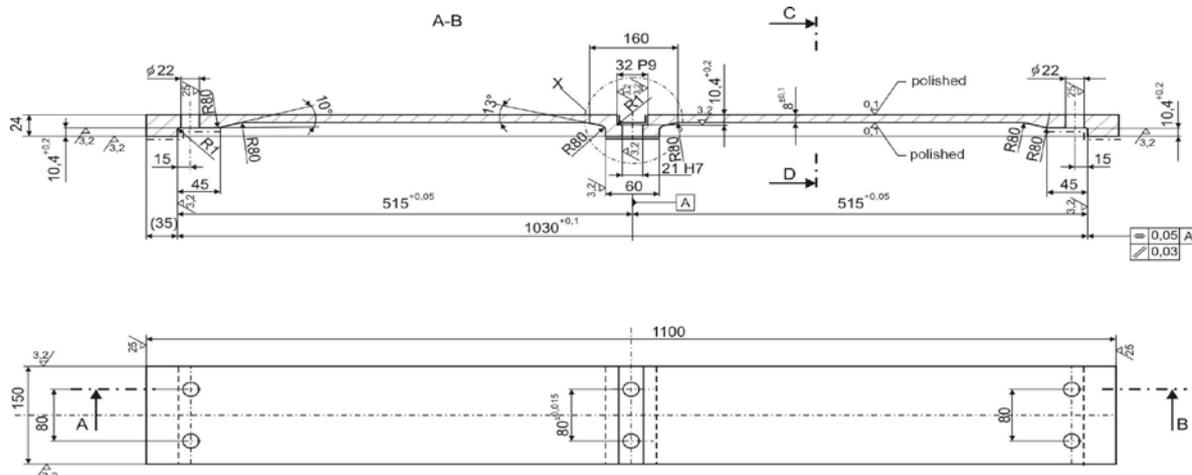
Figure 1. Shape and dimensions of leaf spring

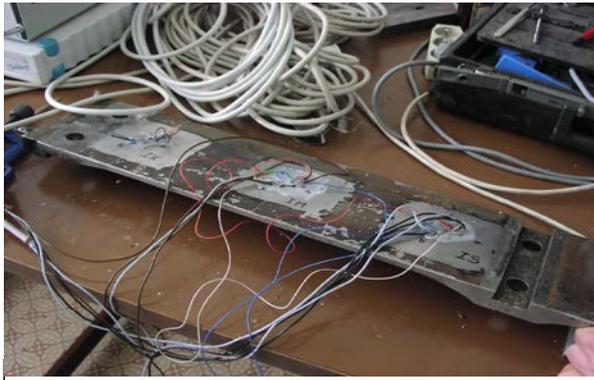
Figure 2. Locations of strain gages RY 61 for the hole-drilling method measurement

During solution of this problem the residual stresses in broken leaf spring were determined by the hole-drilling method. Strain gages for the hole-drilling method [\[1,4\]](#) can be seen in [Figure 2](#). The maximal level of residual stresses (pressure) does not exceed 40 MPa [Figure 3](#).

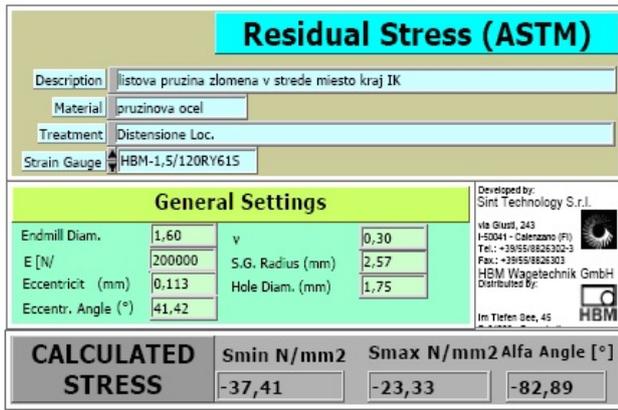
Figure 3. Residual stresses determined by ASTM E 837 01

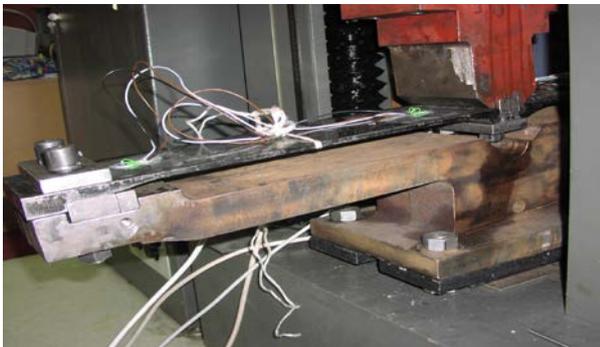
Figure 4. Leaf spring with applied strain gages in tensile test machine

Strain gage measurements of stresses in leaf spring were realized for fastened spring ends and prescribed vertical deformation of leaf spring in tensile test machine [\[2,5,6\]](#). In order to provide the measurements on leaf springs in the tensile test machine it was necessary to use holding fixture because leaf spring is not in horizontal position and axial component of force should cause shifting of spring from pedestal of tensile test machine. Fastening of holding fixture together with leaf spring is given in [Figure 4](#).

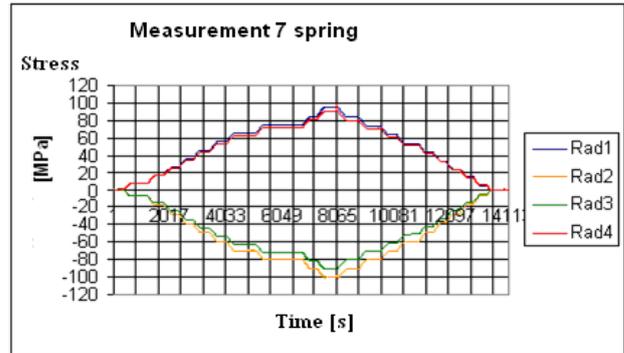
Figure 5. Time-dependent charts of stresses in locations 1,2,3,4

Leaf spring was freely placed on holding fixture and the chucking wedges were completely free. The bolts on the ends of leaf spring were completely free too. After movement of traverse of the tensile test machine to the neighborhood of leaf spring and after equilibrating of strain gage apparatus the measurement began. The records in figures from individual measurements represent stress levels in axial direction of leaf spring in locations 1 to 4 (Figure 5). The steps correspond to the change of deflection by 0.5 mm. The measurement was accomplished during the process of loading as well as unloading.

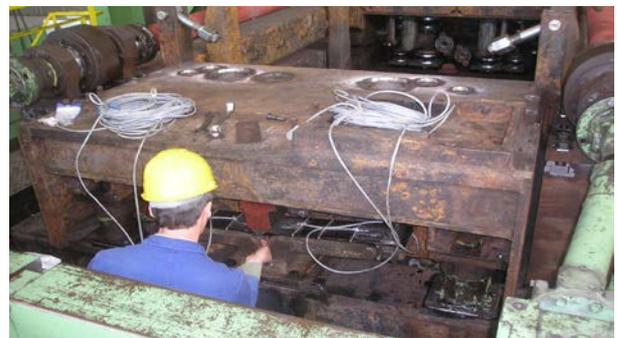
Figure 6. Leaf spring in a frame

The stress measurement of springs in the frame of equipment for continuous casting of slabs was realized after calibration in tensile test machine and after positioning of springs into the frame. (See Figure 6)

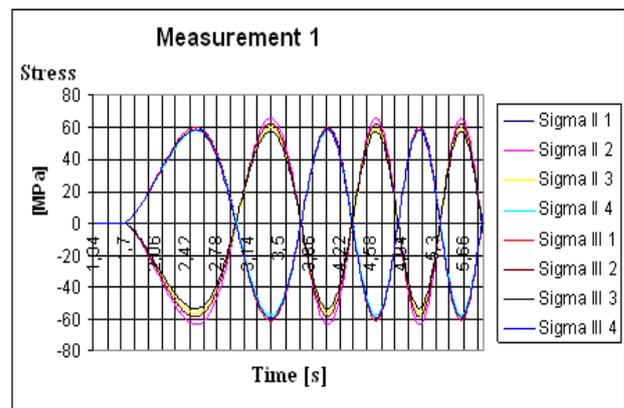
Figure 7. Time-dependent charts of stresses in spring during frame vibration

The measurement was realized on testing stand. For the appraisal of spring behavior during the operation the measurements were realized on testing frame of crystallizer during its vibration. Two leaf springs with strain gages were built into vibration mechanism. After clearing of individual strain gages, there was found out that maximal stress levels registered by all biaxial strain gages during frame vibration are approximately at the same levels and the differences are only in signs of stresses. In Figure 7 are given time-dependent charts of stresses in spring during vibration of crystallizer.

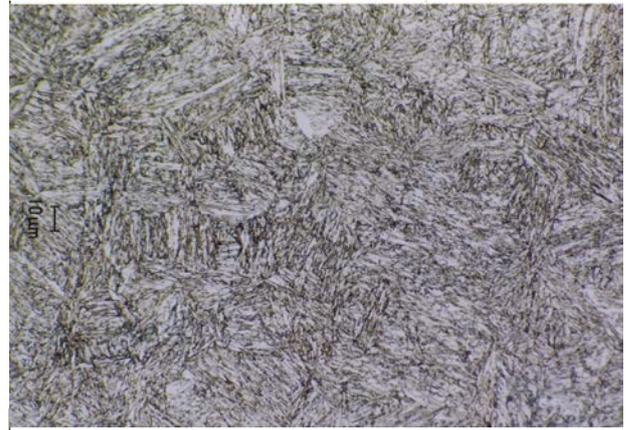
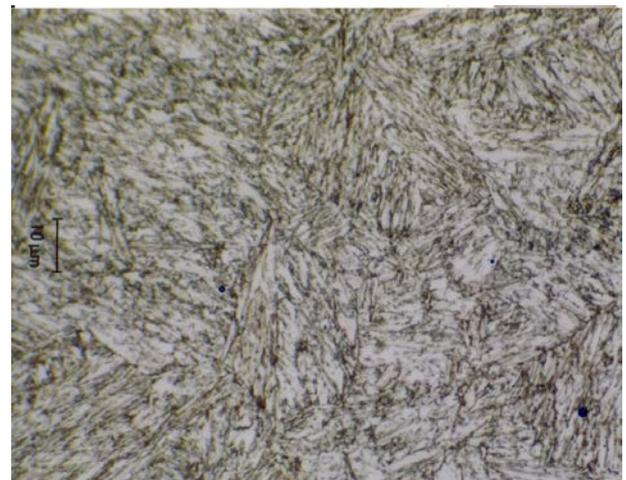
In Figure 8 and Figure 9 is documented the microstructure from the area of geometrical transition of leaf spring (change of spring thickness). Microstructure in Figure 8 and Figure 9 is acicular and it corresponds to low carbonaceous martensit. On the basis of accomplished experiments can be stated that:

Microstructure is composed of coarse annealed needles of martensit with visible boundaries of coarse grain that can have influence to the strength of material. During the analysis of results the authors have given their attention to possibilities of increasing of working life of leaf springs by improving of mechanical properties by more suitable technology of heat treatment.

Figure 8. Microstructure of tested material

Figure 9. Detail of microstructure of tested material

This orientation was caused by fact that microstructure of material contains coarse annealed needles of martensit. Unfortunately, it was discovered that these changes do not remove the problems. It was the reason for using another material for which can be reached yield point 1700 - 1900 MPa and strength limit 1800 - 2050 MPa by appropriate processing. The material for such elements can be based on steels of maraging type. The steels belong to this group not by their chemical composition but by the strengthen mechanism that is based on precipitation of intermetallic phases in matrices (aging) almost non-carbonaceous martensit.

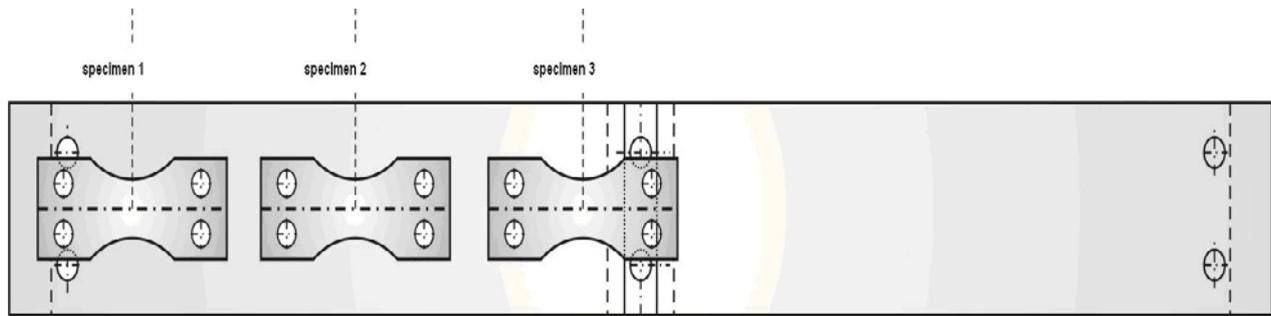
Figure 10. Schema of locations from which the specimens for fatigue tests were taken

The fatigue tests were based on using of testing machine PWY from SCHENCK Corporation. Because leaf spring is loaded for correct setting by symmetrical bending, this type loading was chosen also for this machine. The specimens were made according to Figure 10.

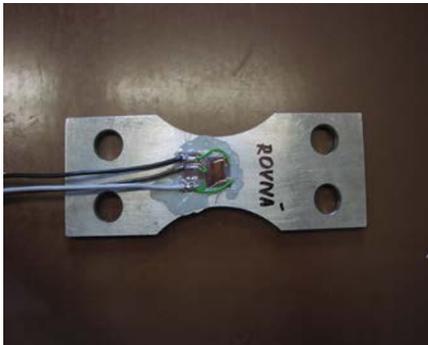
Figure 11. Specimen for fatigue test

On the flat surfaces of specimens 1 to 3 were applied in the most narrow cross sections the strain gages 1-XY91-10/120 with gage factor $k=2.05$ and resistance 120Ω . The grid of the strain gage perpendicular to the axis of the specimen is used for thermal compensation and at the same time in the sense of Hooke's law it comprises also influence of transversal deformation. Specimens 2 and 3 were chosen such a way that they have stress concentrator in the narrowest part of the specimen's cross section. In Figure 11 is shown one specimen taken from leaf spring according to Figure 10.

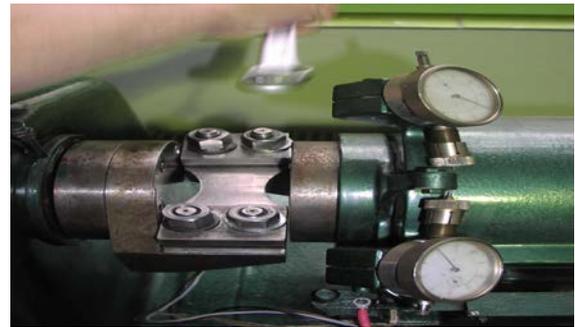
Figure 12. Fixation of test specimen in test machine PWY

Fastening of test specimen in clamping jaw of the testing machine PWY is shown in Figure 12. Fatigue tests of leaf spring were based on the thesis that fatigue limit of leaf spring material is according to State Research Institute of Materials in Prague for symmetrical bending $\sigma_{co} = 0.43R_m$.

Fatigue limit mentioned above is given for the specimen with polished surface. That is the reason why boundary specimen was after its fixation in testing machine Figure 12 loaded by symmetrical bending with amplitude of stress that corresponds to the fatigue limit for symmetrical bending. After $2.6786 \cdot 10^6$ cycles was clearly demonstrated that fatigue limit of this material exceeds this value. Further were increased the stress amplitudes and after certain number of cycles for the defined amplitudes was the specimen damaged.

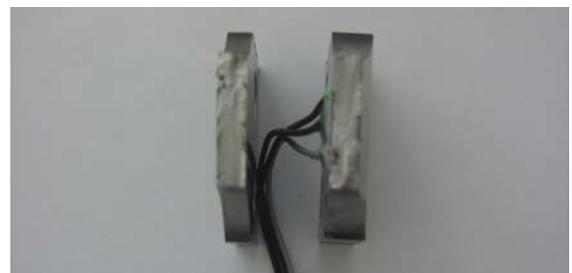
In Figure 13, Figure 14 and Figure 15 photographs of fractured specimens 1 to 3 are given. In Figure 13 is shown fractured surface of specimen 1, in which is in its most narrow location realized transition to the reinforced part of boundary specimen. From the structure of the fracture surface is seen that it contains segregates inclusions visible without microscope. These were probably introduced into the material by incorrect technology of leaf spring production. Inhomogeneous structure of material is located in several points of the cross section (see Figure 13). In the Figure 14 is shown fractured surface of the specimen 2 that was taken from the middle part of spring. This part is without any segregates inclusions or visible defects. In Fig. 15 is fractured surface of the specimen 3 in the area of transition from thin to thicker middle part of spring. In this part of cross section are again visible conspicuous inclusions in the fracture surface.

Figure 13. Fracture surface of specimen 1

combinations, we suggest to use material with significantly higher strength properties.

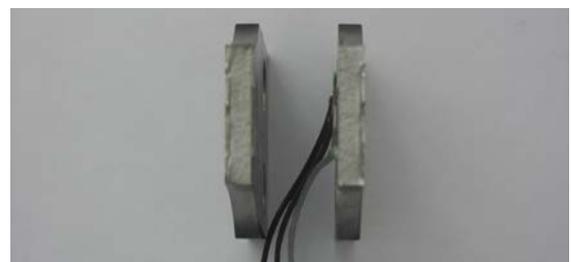
Figure 14. Fracture surface of specimen 2

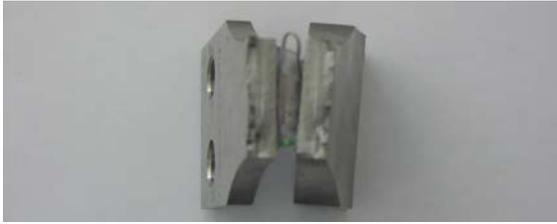
Figure 15. Fracture surface of specimen 3
