# Process Improvements in Automotive Industry

**Abstract** Production processes were optimized to improve quality of production, reduce labor costs, and shorten the lead time of the parts produced. Production line balancing is necessary for manufacturing resource planning, and it is important to optimize the production lines as much as possible to reduce costs and improve productivity

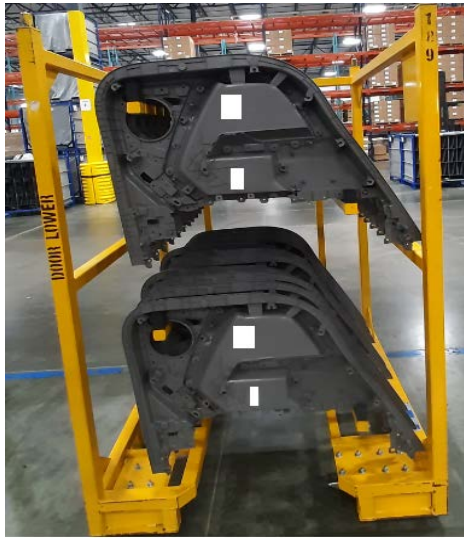
**Figure 3.** Right hand Rear door in old rack structure. Door side B is exposed while side A is meant to be inspected

| Sr. No | List of Task and Action/Results for Project | |
|---|---|---|
| 1 | Door Lower Scanning process must be faster while not comprising on inspection time. | 1)Team members should have ability to observe the door lower while it is in the rack.<br>2) Right hand Door's Rack arms were sawed and rewelded to accommodate this change.<br>3) Modified racks were painted green in order to distinguish between left and right doors. |

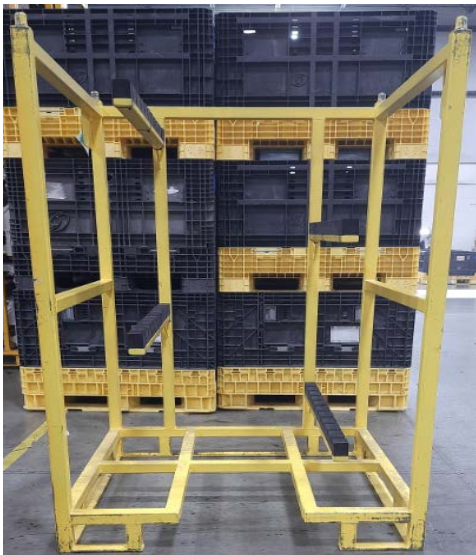
**Figure 4.** Old rack structure which was common for right and left side door causing surface B to be exposed for right side door

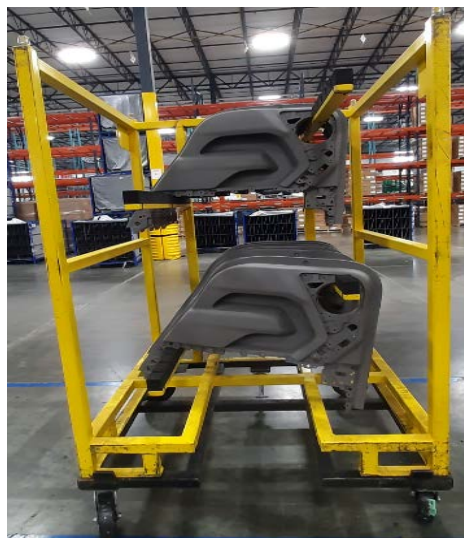
**Figure 5.** Right hand Rear Door in new rack structure. Door side A is exposed which helps team member to inspect door while removal and reduces extra operation of turning the door over

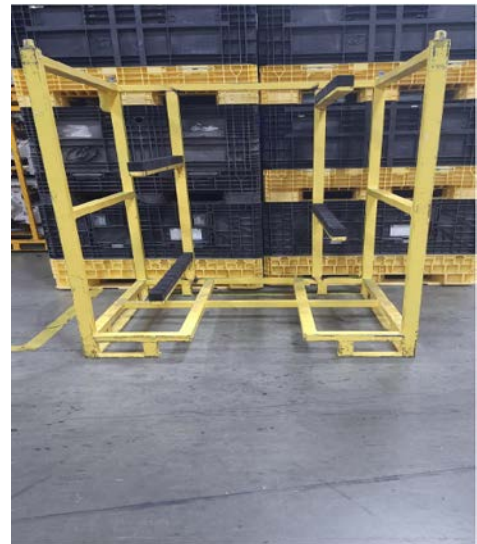
**Figure 6.** New rack structure

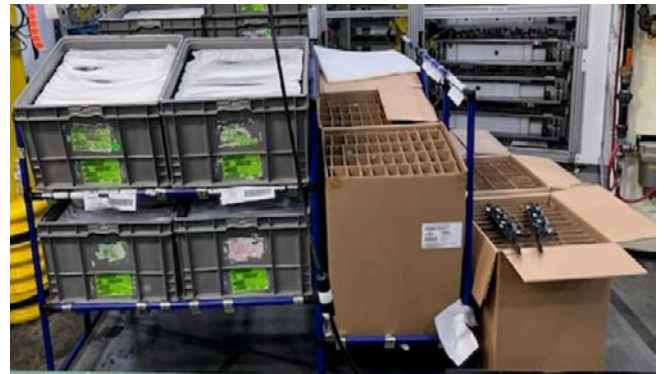
**Figure 7.** Old rack structure for storing speaker grille and decos which made it difficult to return the empty crates

| Sr. No | List of Task and Action/Results for Project | |
|---|---|---|
| 3 | Speaker rack structure not compatible to ensure less operating time. | 1)Speaker grill rack modified to ensure that empty speaker grill boxes are returned easily by the team member at prekit station instead of having to put empty speaker grill boxes near the conveyer where prekit team member worked. |

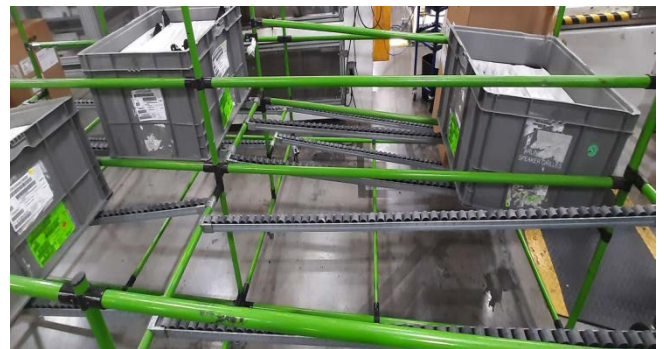
**Figure 8.** New rack structure used sliding mechanism which made it convenient for team member to return the empty crates

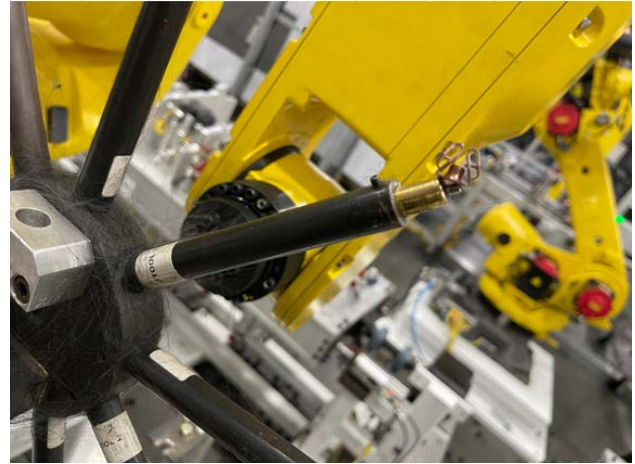
**Figure 9.** Incorrect orientation of pushnut arising from improper magnetization of surface

It was observed that 60% of pushnuts were not being inserted in the slots provided due to wrong design of the robot pushnut fingers. Entire bottom shaft of the finger was magnetized which resulted in the pushnuts picked up oriented in wrong direction when picked up. This was corrected by only keeping the tip magnetized.
