Impacts of Gold Mining Activities on the Morphological Quality Dynamics of the Cavally River (Côte d'Ivoire)

Abstract This study aims to highlight the impact of mining activities on the morphological dynamics of a sub-watershed of the Cavally River at Ity. To achieve this, a remote sensing-based monitoring of land use and land cover changes was carried out in conjunction with an assessment of morphological alterations of the Cavally River over the same period. Analyses were performed using Landsat TM, ETM+, and Sentinel-2 imagery from the years 1994, 2004, 2014, and 2024. The results revealed significant degradation of riparian vegetation in favour of agricultural and extractive activities, leading to alterations in the morphological parameters of the Cavally River. The regression of vegetation was associated with the expansion of settlements, bare soils, and cultivated land. The study highlighted deforestation and soil stripping processes driven by mining operations. The most significant morphological changes were observed along the river reach near the Ity mine. Here, the sinuosity index decreased from 1.79 to 1.24, resulting in the loss of three meanders and a transformation of

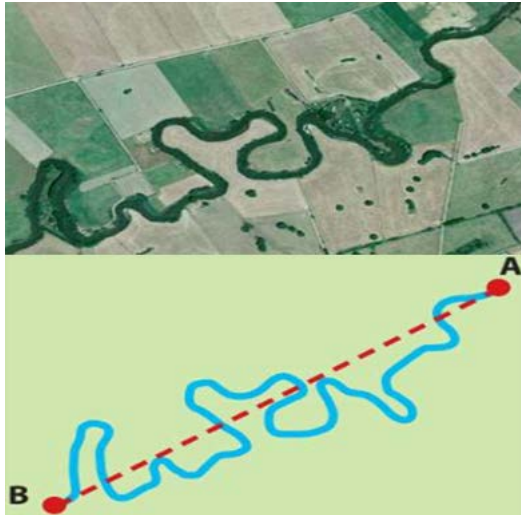
Figure 2. Schematic representation of the sinuosity index calculation for a river reach

As the name suggests, this parameter quantifies the degree of sinuosity of a river channel. It is denoted as IS in French-language publications and P in English-language articles. The sinuosity of a river or a river reach is assessed by comparing the actual channel length to the straight-line distance between the upstream point (A) and the downstream point (B) (Figure 2).

According to Table 3, when the result lies between 1.25 and 1.5, the river is considered sinuous. If the value exceeds 1.5, it is classified as meandering [14].

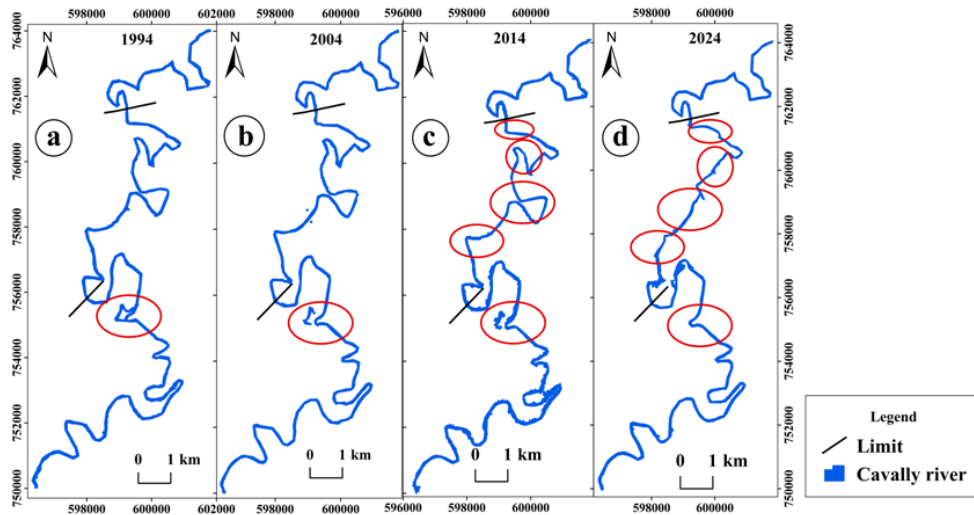
Figure 4. Vectorisation of the Cavally River outline for the years 1994 (a), 2004 (b), 2014 (c), and 2024 (d)

The most significant alterations, in decreasing order of magnitude, concern the active channel length, maximum slope, and sinuosity index, with respective coefficients of variation of 0.38, 0.15, and 0.12 (Table 5). Alterations in channel parameters are negligible for Reaches S3 and S1, whereas the most pronounced changes are observed in Reach 2. In Reach 2, the Cavally River has experienced a notable loss of its meanders, reflected in a considerable decrease in the sinuosity index between 2014 and 2024.

The channel, which was previously meandering with a sinuosity index (SI) of 1.8 in 1994, became significantly straighter, with an SI of just 1.24 by 2024. It is worth recalling that a higher sinuosity index indicates a more sinuous river course.

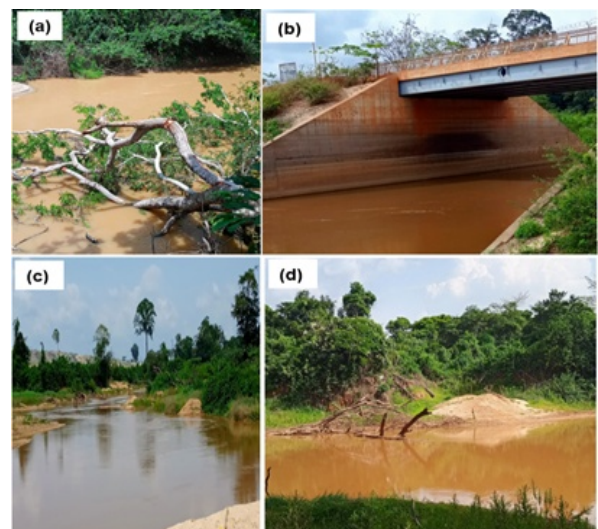
Riparian vegetation plays a crucial role in maintaining the ecological health of river systems and ensuring the usability of water resources by reducing the risk of contamination. However, gold miners, in their quest for gold, create numerous zones of disturbance by exposing root systems or, in some cases, clearing riparian vegetation to facilitate extraction. These uprooted plants are often left to accumulate within the active channel, obstructing hydraulic continuity (Figure 6a). Due to a lack of appropriate equipment, artisanal mining activities primarily target riverbed sediments for gold extraction. Mining occurs both along the banks and within the active channel. The removal of sediments from the banks increases the width of the river channel bed at these locations by expanding the mean channel bed (Figure 6c). Additionally, excavation within the active channel disrupts the natural balance between sediment deposition and erosion, which has direct consequences for the fluvial dynamics of the Cavally River (Figure 6d).

Figure 6. Impacts of channel and bank artificialisation along the Cavally River

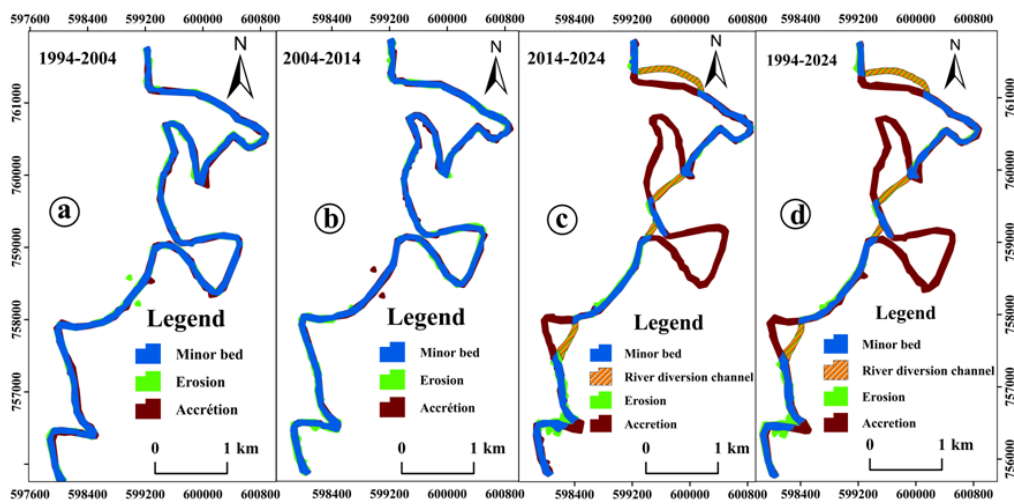
Figure 9. Erosion and accretion dynamics of the Cavally River along Reach 1 between 1994–2004 (a), 2004–2014 (b), 2014–2024 (c), and 1994–2024 (d)
