The Upshot of the 2012 Flooding on Structural Components and Fabrics of Buildings at Ogbaru, Anambra State Nigeria

Abstract The study examined the effect of the 2012 flooding on structural components and fabrics of buildings at Ogbaru Local Government Area of Anambra State. It also examined the heights of the ground floors and foundations of the buildings respectively in relation to the height of the flood. Questionnaire survey on the selected households and physical examination on the building structures were carried out. The study revealed that most buildings in the area were either fully or partially submerged during the flood incidence. It further revealed that there were no very severe damages on the structural components of the buildings, despite that most of the buildings have low ground floor levels (74%) and shallow foundations (68%) below 300mm. However, building fabrics and elements such as finishes and electrical fittings were severely damaged when the flood height rose 1 metre above the ground floor level. More so, the study revealed that the flood severely damaged both the structural components and fabrics of very old, weak and mud buildings. Based on this, the study

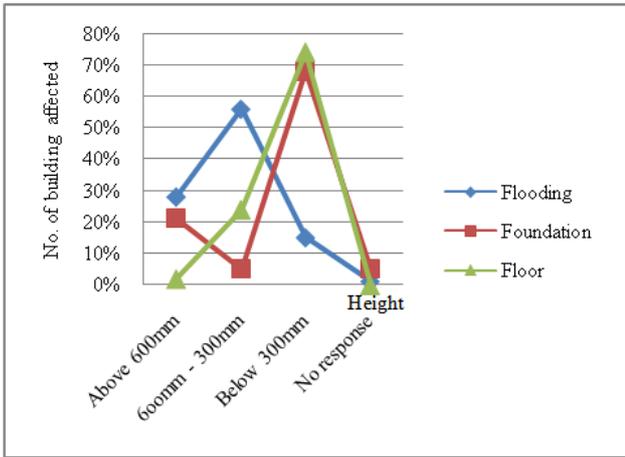
Figure 3. Height of Flooding and Depth of Foundation

From Figure 3, about 68% of the buildings have foundations depths of 300mm or less (see also plate 1). Likewise, more than 74% of the buildings have ground floor level height of 300mm or less. Figure 1 also showed that during the 2012 flooding, about 56 % of the buildings showed flood depth mark of between 300-600mm, 28% showed flood depth mark of more 600mm. It further revealed that this depth increased significantly during the flooding and got to a depth of more than 1m. With the water rising above the floor level and coming into contact with internal finishes, it left most of the fittings and fabrics damaged.

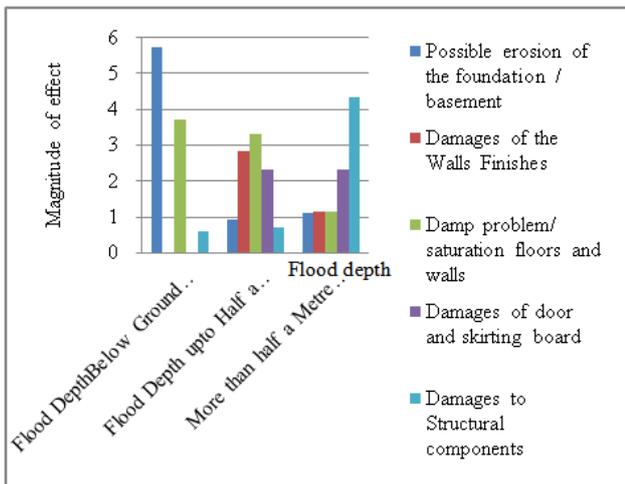
Figure 4. Effects on Structural Components and finishes

Figure 4 revealed that when flood level was below the ground level, erosion of the foundation/basement was pronounced. When the flood came up to half a metre above the ground floor level, walls finishes, Damp problems/saturation of floor and walls, and damage of door and skirting became common. But when the flood depth was more than half a metre above the ground floor level, damages to structural components of buildings ensued.

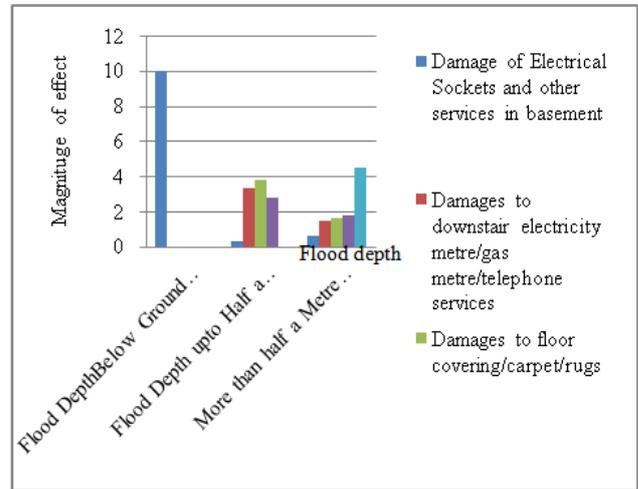
Figure 5. Effects on building Services and Fittings

Figure 5 revealed that at when flood level was below ground level, basement fittings were more vulnerable.

When the flood came up to half a metre above the ground floor level, damages of downstairs electricity, floor covering and kitchen were common. But when the flood depth was more than half a metre above the ground floor level, damage of higher units/electrical services and appliances were severely affected.

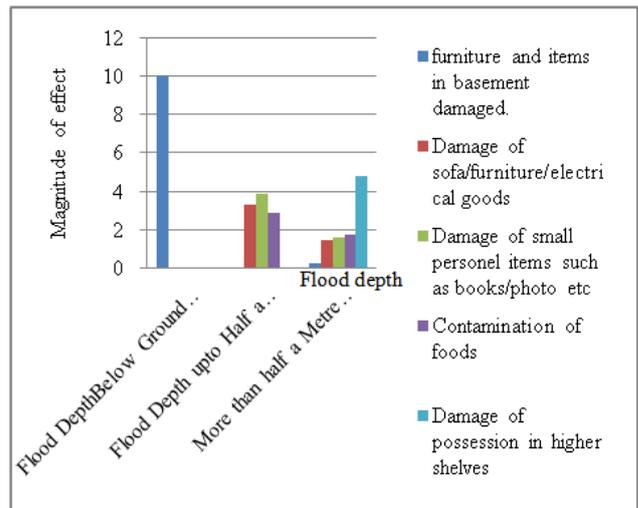
Figure 6. Effects on furniture and items in the buildings

Figure 6 revealed that at when flood level was below ground level, personnel possession and furniture at basement were severely affected. When the flood came up to half a metre above the ground floor level, damages of downstairs sofa, books and contamination of foods were more common. But when the flood depth was more than half a metre above the ground floor level, damage of possession at higher shelves were severely affected.
